Conserving Heritage Tiles on the London Underground: Challenges and Approaches

Kate Fulcher*

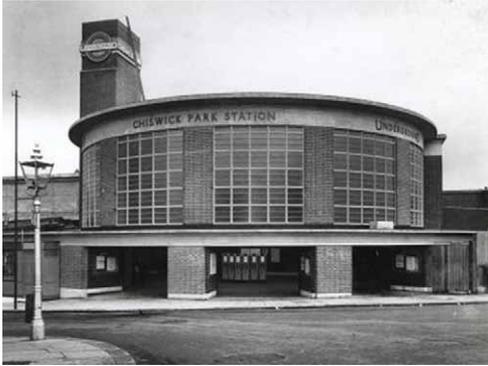
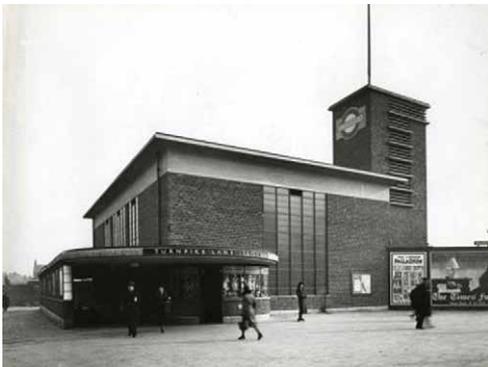
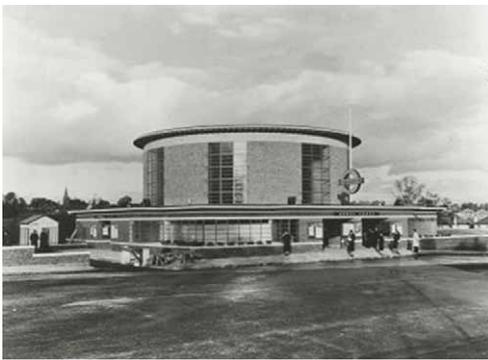
Fig. 1: Examples of London Underground stations designed by architect Charles Holden. From top: Chiswick Park (photographed by Topical Press 12 Oct 1932, LTM U11500); Turnpike Lane (photographed by Topical Press Jan 1933 - Mar 1933, LTM U11887); Arnos Grove (unknown photographer 1932, LTM unknown image number).

The Yerkes stations of 1906/7 are one group of Underground tiled stations dealt with in this research, consisting of forty-six stations across the Bakerloo, Hampstead (Northern Line) and Piccadilly Lines (Rose 2007, xi). The second type of station considered in this study are those designed by or in the style of Holden under Pick, modernist statement pieces dating from the early 1920s to the end of the 1940s (Figure 1).

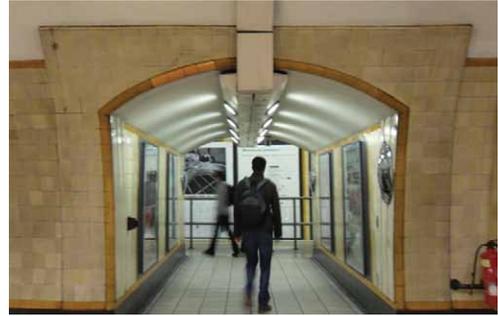
Fig. 2: Patch repair at Turnpike Lane around concourse entrance to platform. Note new bright yellow tiles on the entrance surround (author's photo).

Turnpike Lane was opened in September 1932 as part of the northern extension of the Piccadilly Line, designed by Charles Holden (FDKC Architects 1993a). Turnpike Lane station is Grade II listed (LUL 2006a, 105-113), so in order to preserve undamaged original fabric it was decided that the best way forwards was to patch repair an agreed percentage of the tiles (M. Ashworth, *pers. comm.*, April 2010; Dunn 2007; LUL 2006a, 121). This agreed percentage was used to quantify the limit at which it would no longer be

worth replacing tiles one by one, and was set, after much debate, at about 20%-30% within a defined area (M. Ashworth, *pers. comm.*, August 2010). In addition, some of the original tiles were cold resin repaired (Dunn 2007). Cold resin repair is a method of infilling small chips in tiles, usually with pigmented polyester or epoxy resin mixed with an activator for quick setting at room temperature in variable humidity (Buys & Oakley 1993, 124; Durbin 2005, 131-132; J. Southern, *pers. comm.*, June 2010). Individual unviable tiles were removed using a diamond edged cutting blade in a process described by Lesley Durbin (2005, 135), and newly made replacement tiles inserted into the spaces left (D. McCartney, *pers. comm.*, July 2010).

The final result of this work was viewed negatively from all sides (M. Ashworth, *pers. comm.*, April 2010; A. Blundell, *pers. comm.*, June 2010; Dunn 2007; LUL 2006a, 121). The visual impact was unappealing, with clean, bright areas adjacent to what appeared in comparison to be dirty uncared for areas (Figure 2). Three different tile finishes – original, resin repaired and replacement, led to what an English Heritage publication has referred to as “a visually discordant patchwork” with an “inconsistent palette of colours and tones” (Dunn 2007). In addition, the process was time consuming and labour intensive and thus expensive (M. Ashworth, *pers. comm.*, April 2010; D. McCartney, *pers. comm.*, July 2010), making it impractical for roll out over many stations.

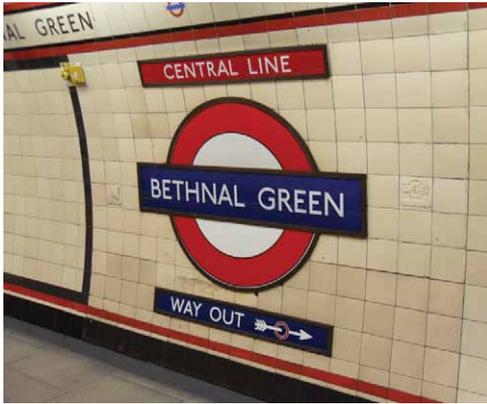
Fig. 3: Original area of tiling at Bethnal Green, bounded by black strip on the left and ending 4 tiles after the arrow on the right (author's photo).

Bethnal Green, a Holden-style station, opened in 1946 on the Central Line eastern extension that had been put on hold by the Second World War (Bruce & Croome 2006, 48; Davis & Bayne Architects 1993, 5). The tiles used for the platforms were of the “Poole” type also used for the northern Piccadilly Line extension that included Turnpike Lane. The platforms were retiled using replica tiles at the end of 2006 (A. Blundell, *pers. comm.*, June 2010), leaving six original panels, three on each platform. The result is a clean and consistent finish; the difference between the old and new sections is only clear if it is purposefully sought out (Figure 3).

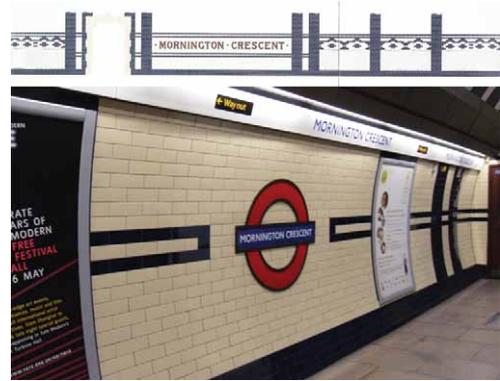
Fig. 4. Above: Section of the original tile scheme at Mornington Crescent (Rose 2007, pull out "The Hampstead Stations"). Below: Retiled platform at Mornington Crescent (author's photo).

In other cases, stations whose tiling patterns were well known have been stripped and retiled in a totally non-original design (D. Rose, *pers. comm.*, June 2010). Figure 4 shows the original design and retiled pattern at Mornington Crescent, a Grade II listed station opened in 1907 whose platform tiling was replaced in the mid-1990s (Bailey 1993c, 7; Rose 2007, 142-143). The only way in which this tiling change can be said to have conserved the originals is in the shape and colours of the tiles.

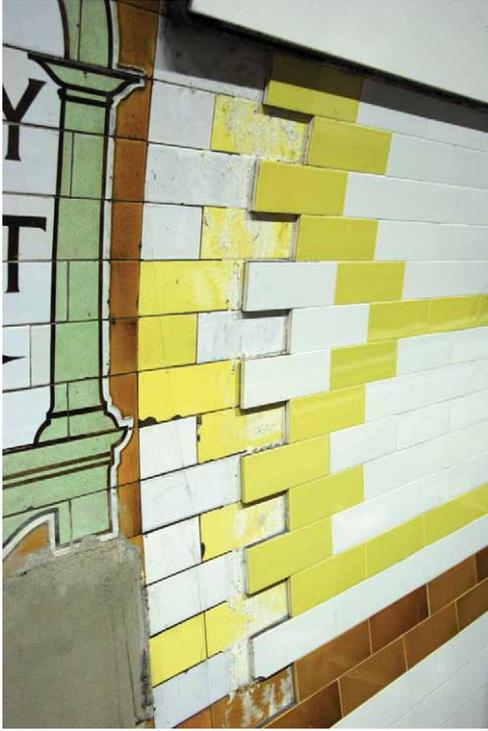
Fig. 5. Over-tiling at Covent Garden (photo courtesy of Douglas Rose, 2008: http://www.dougrose.co.uk/index_tiles.htm [accessed October 2012]).

Figure 5 shows the over-tiling on the platforms at Covent Garden, a Yerkes station that

opened in 1907, which lies within the Covent Garden conservation area, although it is not itself listed (Bailey 1993d, 5, 7). As can be seen in the picture, the tile pattern has been faithfully copied, but the original tiles were in good condition, so it is has caused disappointment that the retiling was done at all (M. Ashworth, *pers. comm.*, August 2010; D. Rose, *pers. comm.*, June 2010). The work was carried out due to the infraco’s contractual obligations to increase the station’s ambience score; over-tiling is a great deal cheaper than the other approaches discussed, and Covent Garden station is not listed, so London Underground could not find an argument for keeping the original tiles that the infraco would accept (M. Ashworth, *pers. comm.*, August 2010). However, London Underground did manage to persuade them to use square edged tiles in good colour matches for the over-tiling.

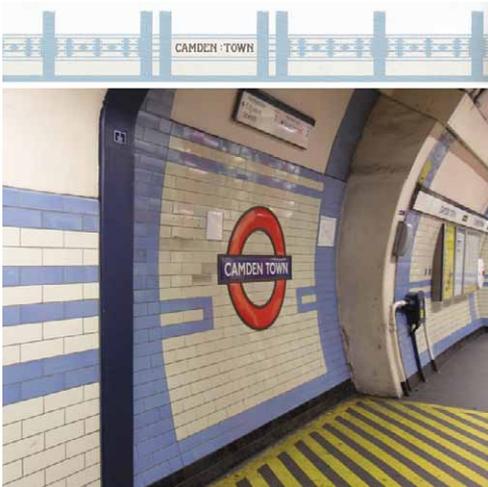
Fig. 6. Above: Section of the original tile scheme at Camden Town (Rose 2007, pull out “The Hampstead Stations”). Below: Retiled platform at Camden Town (author’s photo).

At Camden Town the over-tiling work was carried out in 2001, and does not attempt to replicate the original tile scheme on the platforms (Rose 2007, 140-141). The same colour is used, but, as at Mornington Crescent, the pattern is reduced to a double line (Figure 6).
